A rare case series of mechanical prosthetic heart valve structural deterioration presented as severe mitral regurgitation

Case presentation: We report two cases of severe mitral regurgitation due to structural deterioration of TTK Chitra mechanical heart valve (disc fracture) in mitral position.

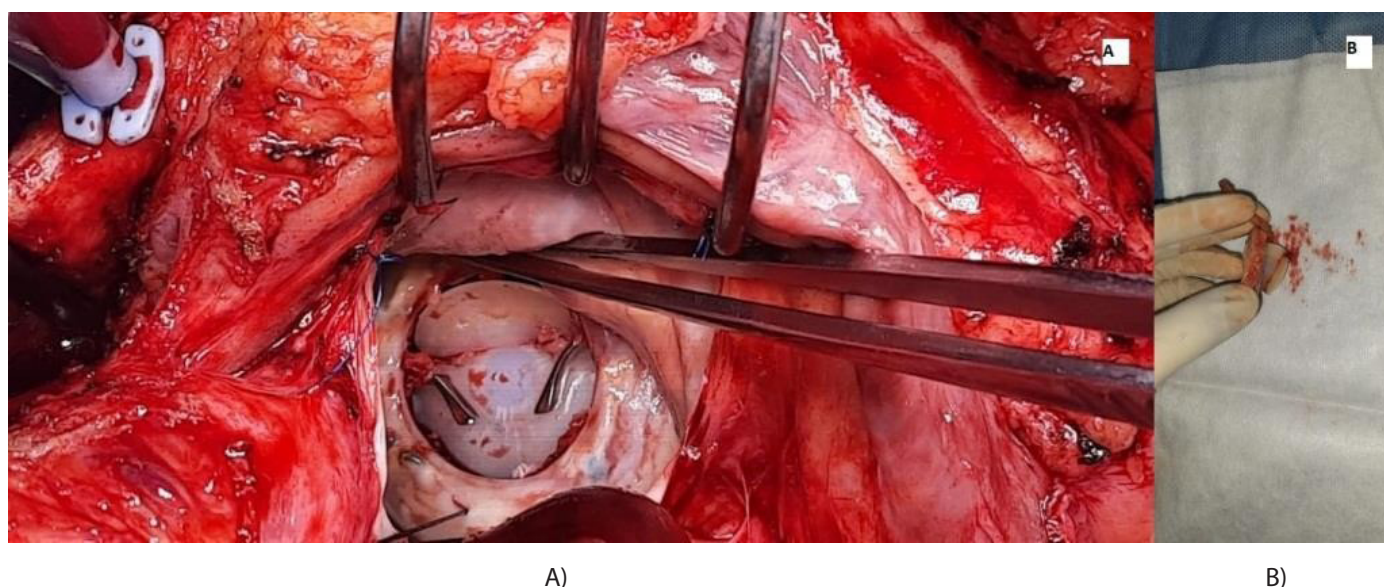
Figure 1. Case 1. A) Photograph with in situ TTK CHITRA valve with disc fracture B) Photograph of explanted TTK CHITRA valve in case 1

On auscultation, prosthetic valve click was audible, grade 4/6 pan-systolic murmur over mitral area and basal crepitations were present. Two-dimensional transthoracic echocardiography (2d Echo) showed severe transvalvular mitral regurgitation (MR) (ratio of MV inflow velocity time integral (VTi) and left ventricular outflow tract (LVOT) VTi of 1.68 and the jet occupying almost full of left atrium and hitting the roof of left atrium) and pannus formation with restricted leaflet movement with left ventricular ejection of 40%. Transesophageal echocardiography was done, which was suggestive of the same findings. Therefore, he was planned for redo MVR after informed consent was obtained. After uneventful redo sternotomy, cardiopulmonary bypass was established. Left atrium was opened and prosthetic MV was assessed. There was transverse disc fracture which caused severe valvular mitral regurgitation (Fig. 1). The valve was explanted in toto and examined. Although the disc was fractured, no part of the disc was missing. A new 29 mm St Jude's Medical mechanical valve reimplanted. Postoperative recovery was good. He is asymptomatic at 6 months follow up, had started his routine activities after 2.3 months of surgery and 2D echo showed normal prosthetic valve function with normal biventricular function.
