Echocardiographic evaluation of heart valve prosthetic dysfunction

Yuriy Ivaniv

Diagnostic Radiology Department, Danylo Halycky National Medical University, Lviv, Ukraine

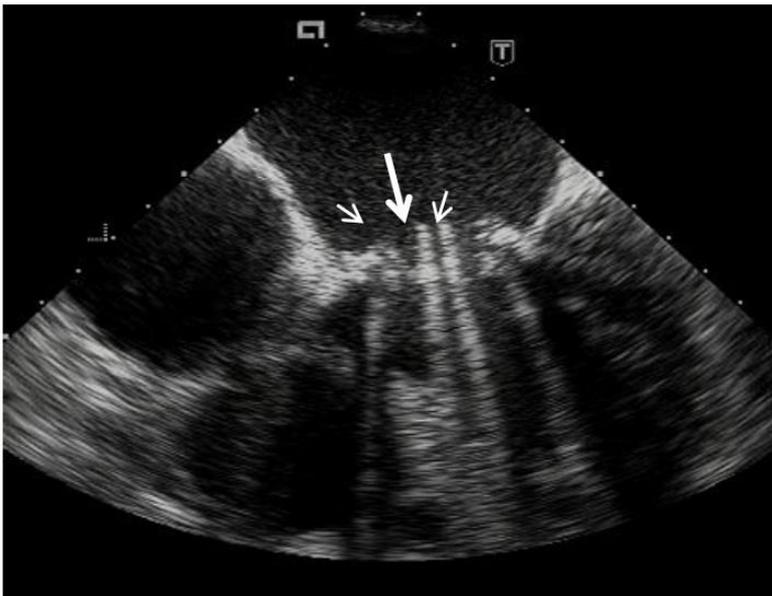
Fig. 1. Transesophageal visualization of prosthetic bileaflet valve opening. Clearly seeing two disks in opened position as a parallel lines with intensive shadowing down. It is also visible three parts of prosthetic orifice: the smallest one at the center between the two opened cusps (long arrow) and two bigger orifices laterally (short arrows).

There are three main types of mechanical valves, which differ primarily by the construction and functioning of occluders: tilting disk, bileaflet, and ball-and-cage. Monoleaflet tilting disk valves consist of a circular plain occluder which usually opens to the angle 60-80°. Bileaflet valves have occluders presenting by two semilunar disks attached to a rigid ring by tiny hinges (Fig. 1). The opening angle of the discs relative to the ring plane achieves 75-90°, and the orifice of this valve has three parts: the smallest one at the center between the two opened cusps and

two bigger semicircular orifices laterally. Caged-ball valves consist of a silastic ball with a circular metal ring and a cage formed by two or three metal arches (2).

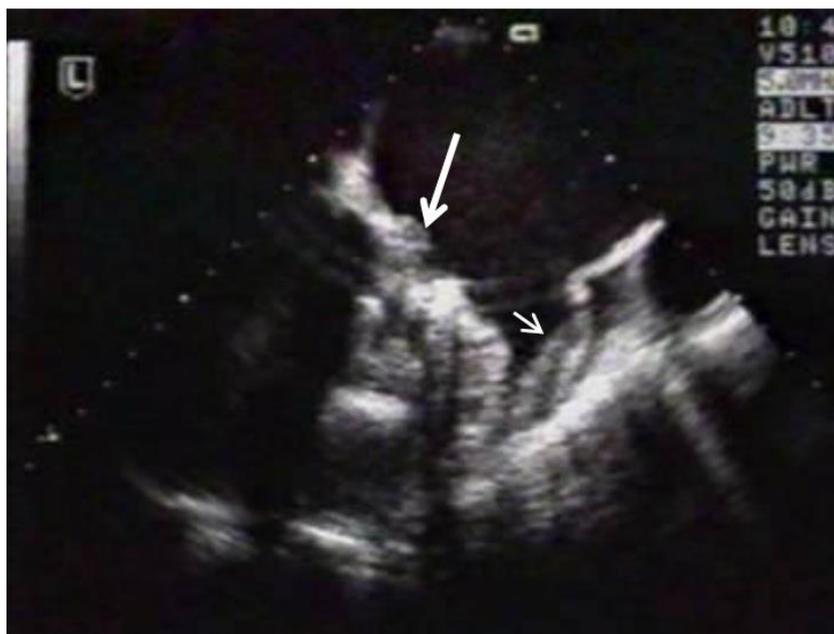
Fig. 2. Transesophageal echocardiography of thrombus obstructing the orifice of mitral valve prosthesis (long arrow). At the same time the thrombus in left atrial appendix is visualized (short arrow).

- 1) limited opening or completely blocked disc movement on the fluoroscopic examination;
- 2) elevated Doppler gradients on the prosthetic valve on transthoracic echocardiography (TTE);
- 3) detection of the thrombus during transesophageal echocardiography (TEE) (Fig. 2).

A thrombus on a prosthetic valve could be rarely visualized during transthoracic examination due to the presence of intense artifacts and ultrasound signal reverberation (17). In most cases prosthetic thrombosis develops rapidly with a dramatic increasing of heart failure manifestations.

TTE examination in these patients reveals an elevated pressure gradient on the prosthesis and a reduced effective orifice area, and occluding clots should be detected using transesophageal examination (18).

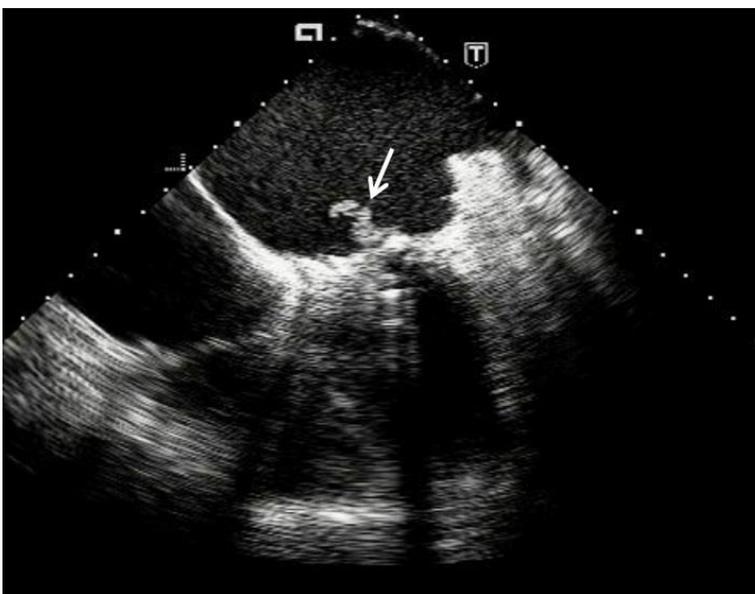
Fig. 3. A long vegetation (arrow) attached to the atrial surface of mitral valve prosthesis visible by transesophageal echocardiography

Infective endocarditis could be a cause of prosthetic valve dysfunction (Fig. 3). Its main echocardiographic manifestations include vegetation, thrombi on the replaced valve structures, dehiscence of the prosthetic ring, abscesses, pseudoaneurysms, fistulas and paravalvular regurgitation (32, 33). It should be kept in mind that insignificant paravalvular jets often happen even in the absence of endocarditis. The sensitivity of TEE in the detection of thrombi and vegetation in prosthetic valve infective endocarditis is much more higher (almost 90%) than transthoracic method (not more than 40%) (34-36).

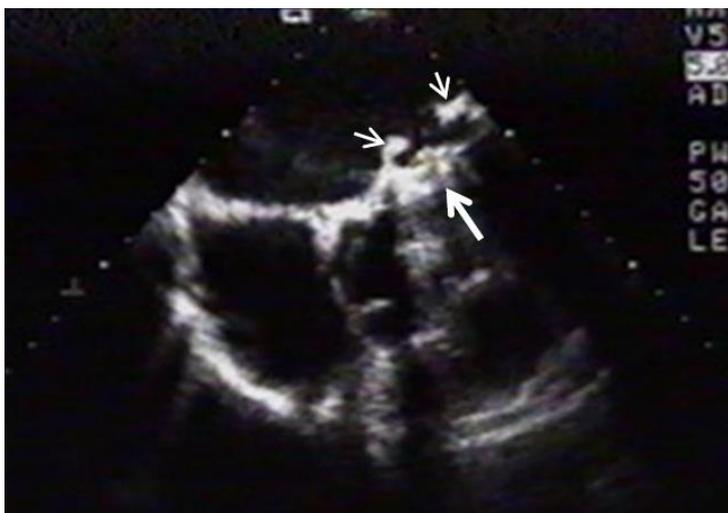
Fig. 4. Pannus formation from the atrial side of mitral valve prosthesis (short arrows) visualized by transesophageal echocardiography. Partially opened prosthetic disk is limited in its movement by thrombus (long arrow).

One more cause of prosthetic valve dysfunction is pannus formation. Pannus is a connective tissue progressively growing into the orifice of the prosthesis and gradually obstructing it (1, 37). The pathophysiology seems to be explained by a chronic inflammation that results in the gradual and late clinical presentation looking like a thrombosis. But the correct diagnosis of pannus is critically important for choosing a treatment method since fibrinolytic agents could resolve thrombosis and have no effect on pannus (38). Cases of pannus are possible to diagnose mostly by TEE (Fig. 4). According to the published data, the incidence of this complication is 1.6%-2% in the different series and occurs exclusively in mechanical prostheses more often in the aortic position (39, 40).
